## PIPELINE INVESTIGATION REPORT

### NATURAL GAS PIPELINE RUPTURE

WESTCOAST ENERGY INC.

762-MILLIMETRE T-SOUTH MAINLINE, MILE POST 569.9

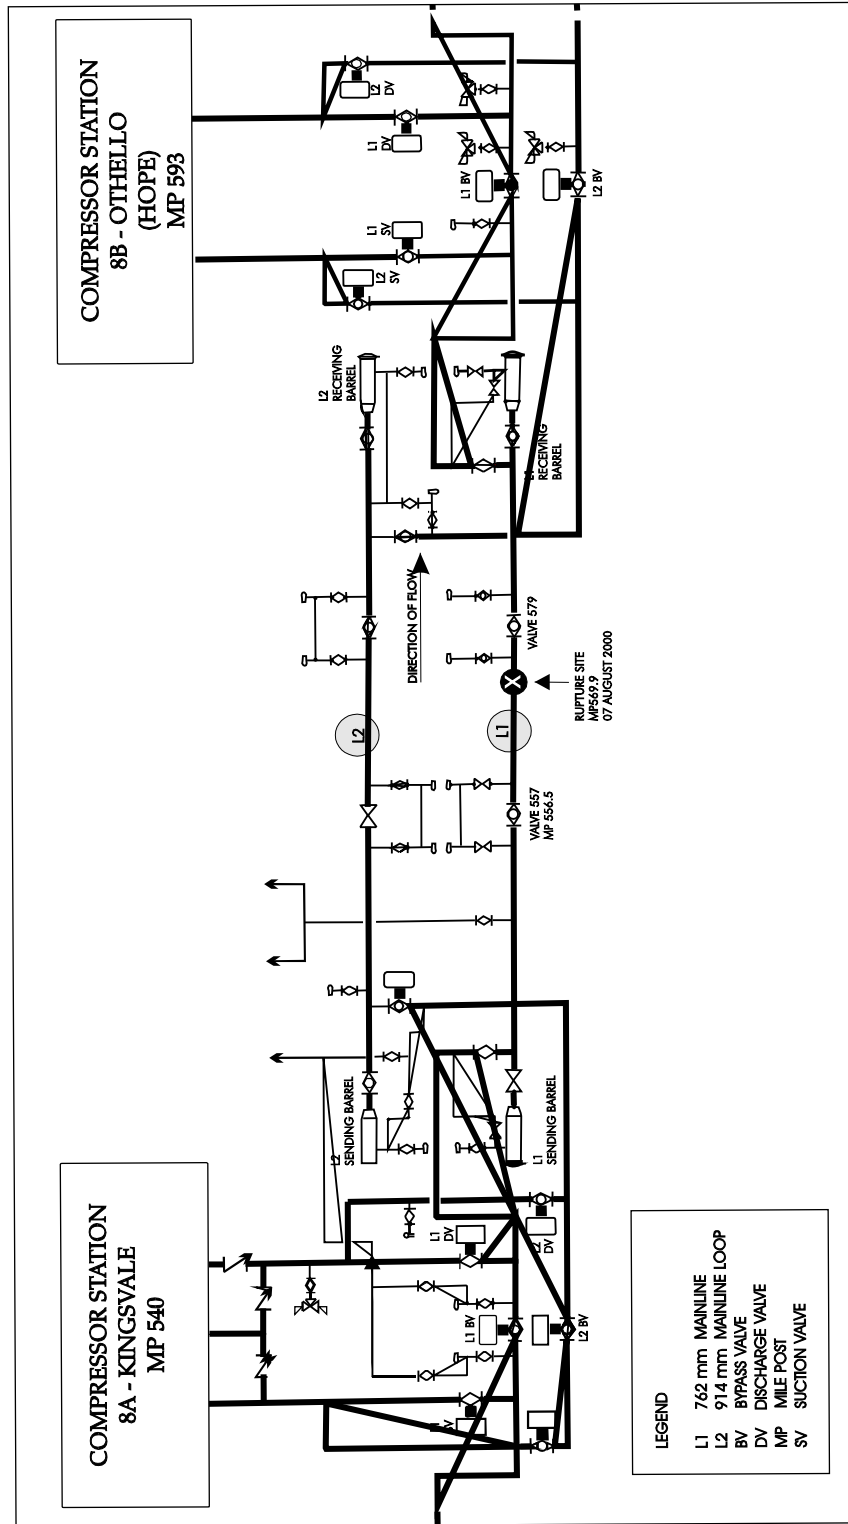
# Appendix A - Schematic of T-South Mainline and Loop between Compressor Stations 8A and 8B
